DEPARTMENT OF NATURAL RESOURCES AND CONSERVATION  
DAM SAFETY INSPECTION

NAME OF DAM Ruby Dam  
DATE INSPECTED October 6, 2008

INVENTORY NO. MT 4  
HAZARD CATEGORY HIGH  
TYPE OF DAM Earth  
YEAR BUILT 1938

## Ruby Dam 2008 Annual Inspection Photographic Log

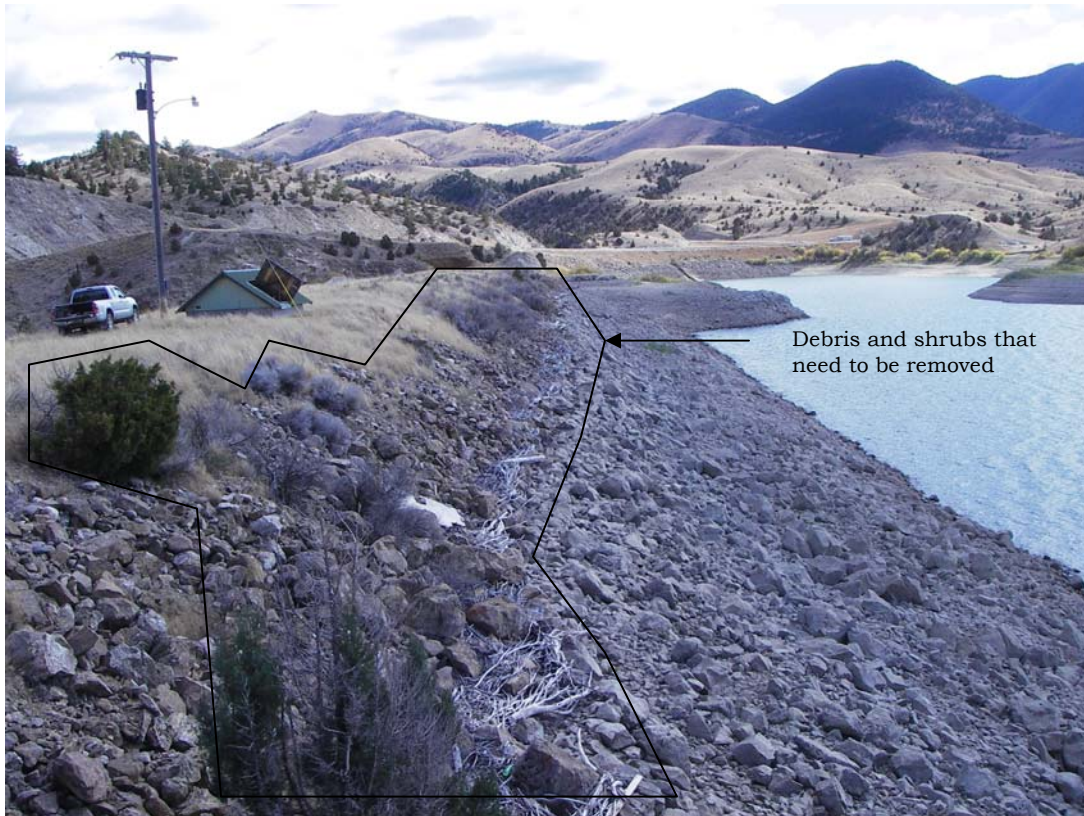
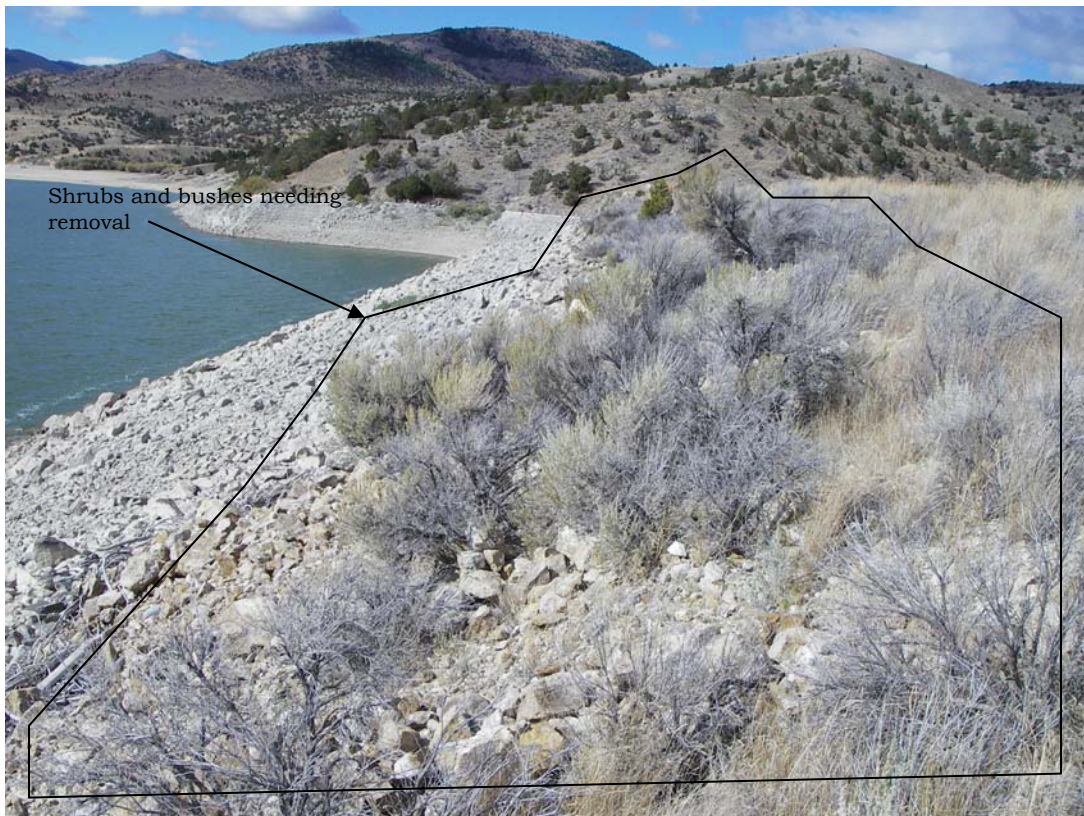
**Section 1.B.(8).** There is a minor accumulation of branches and small logs on the upstream face which need to be removed (Photos 1, 2).

**Section 1.B.(9).** There is some sagebrush on the upstream face that needs to be sprayed/removed (Photos 1, 2).

Photo 1 – Crest and upstream embankment (looking east).

Photo 2 – Upstream embankment (looking west).

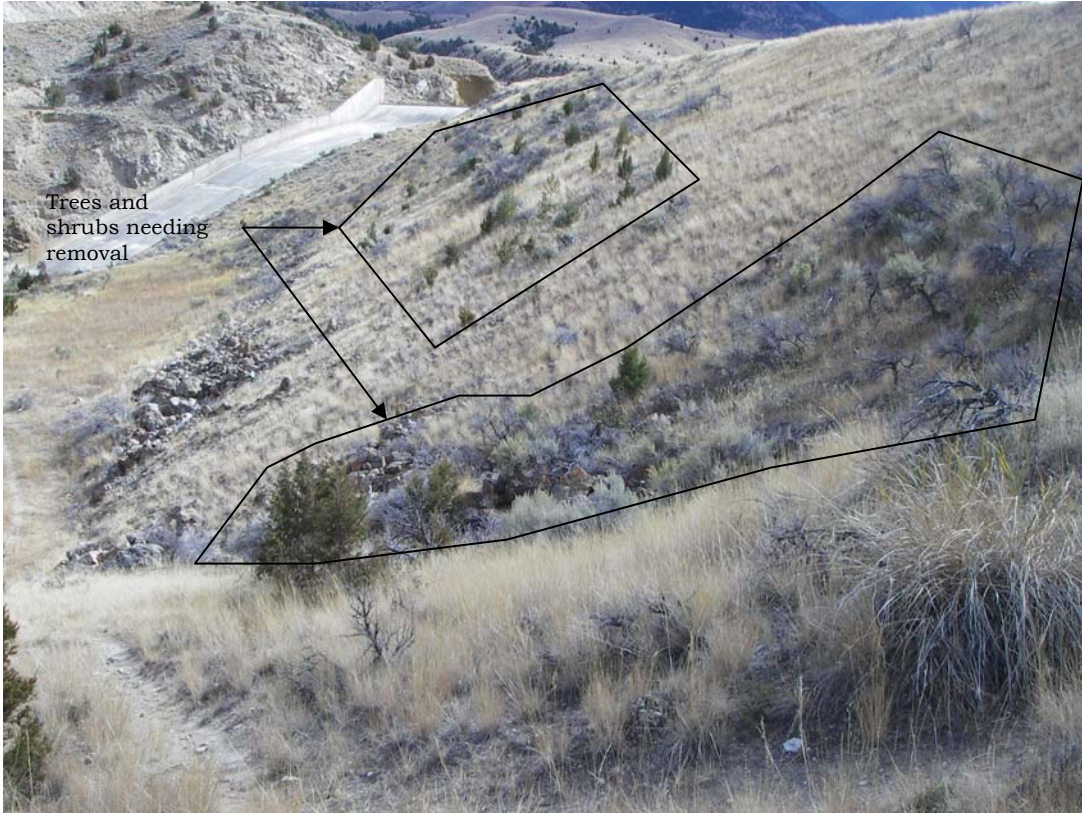
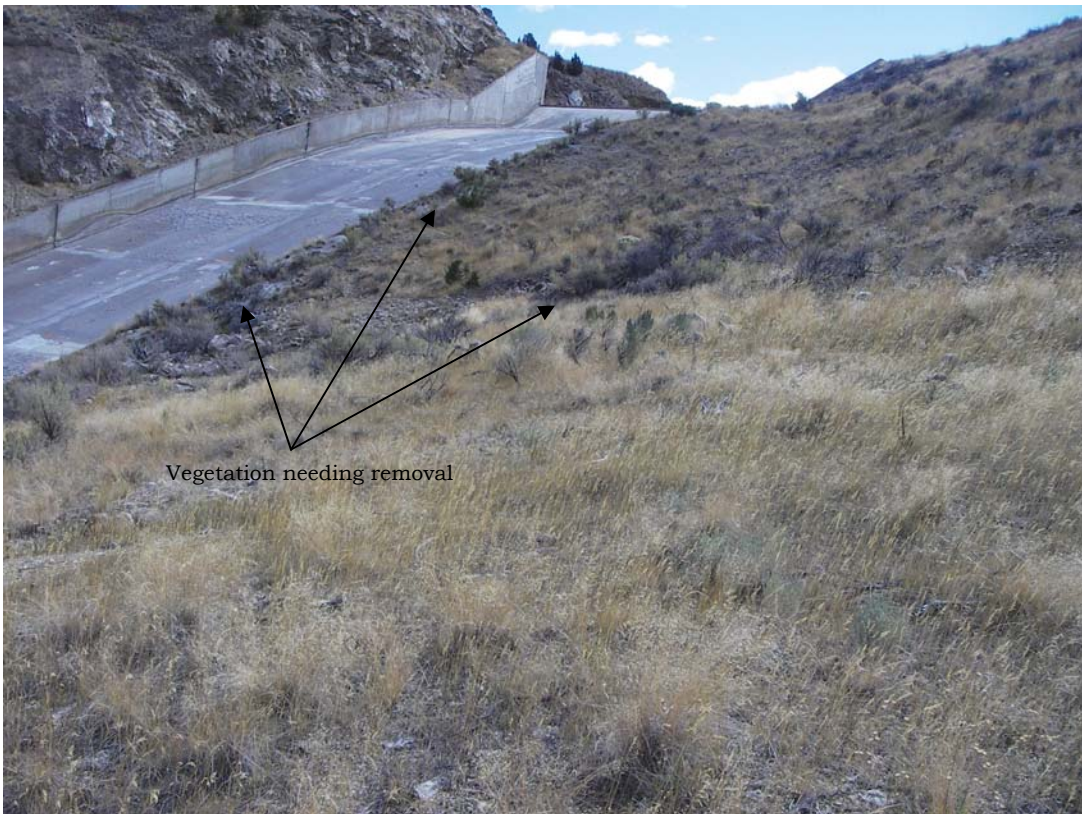
**Section 1.D.** There are bushes and small trees scattered on the downstream face of the embankment (Photos 3, 4). The sage brush is especially thick on the lower portion of the downstream face and at the toe. The bushes, trees, and sage brush need to be removed.

Photo 3 – Downstream embankment (spillway in background).

Photo 4 – Downstream embankment and spillway.

2. Spray/kill and remove the trees and the large brush on the downstream face of the dam, the upstream face of the dam, and around the outlet works. Focus the efforts around and above the outlet portal and along the embankment toe (June 2009).

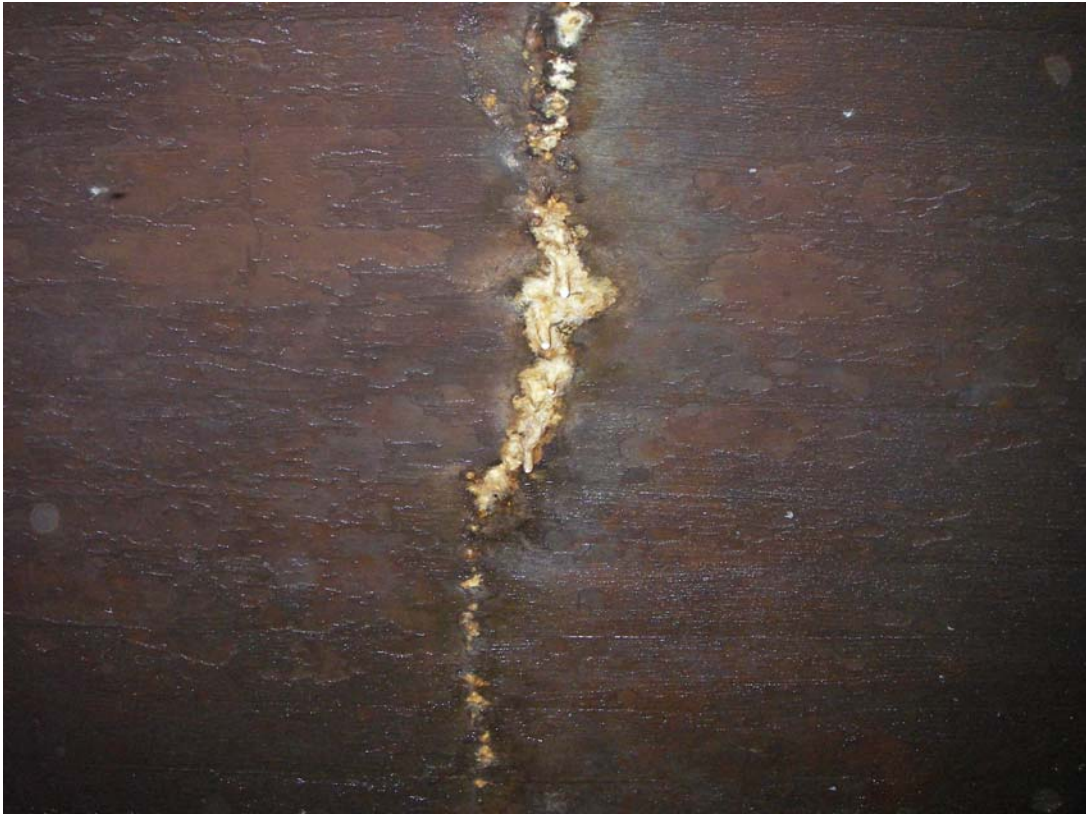
**Section 3.B.(2).c.** There are approximately fifteen cracks/joints in the downstream portion of the conduit that appear as though they have leaked a small amount at some point. There is no evidence of sediment transport. (Comment from 2007 Inspection).

During the 2008 Inspection, one old crack was observed which had built up calcium deposits (Photo 5). No changes were noted from previous inspections.

Photo 5 – Crack in conduit with calcium deposits.

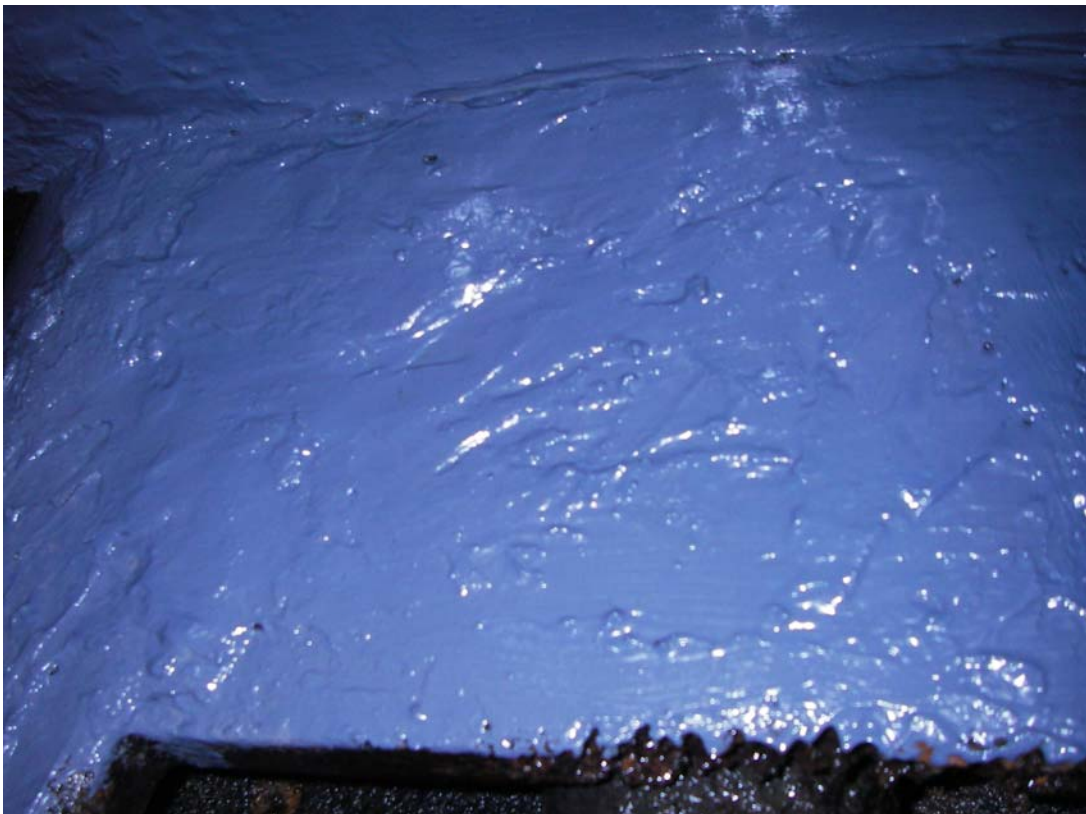
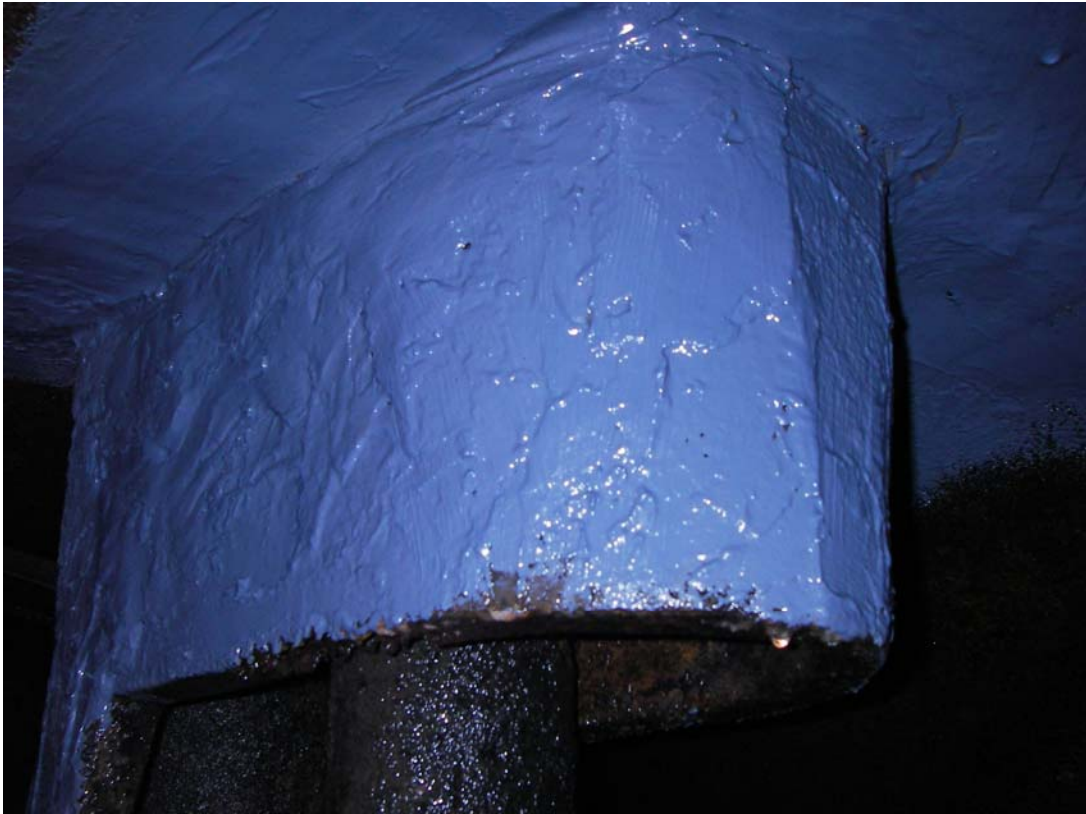
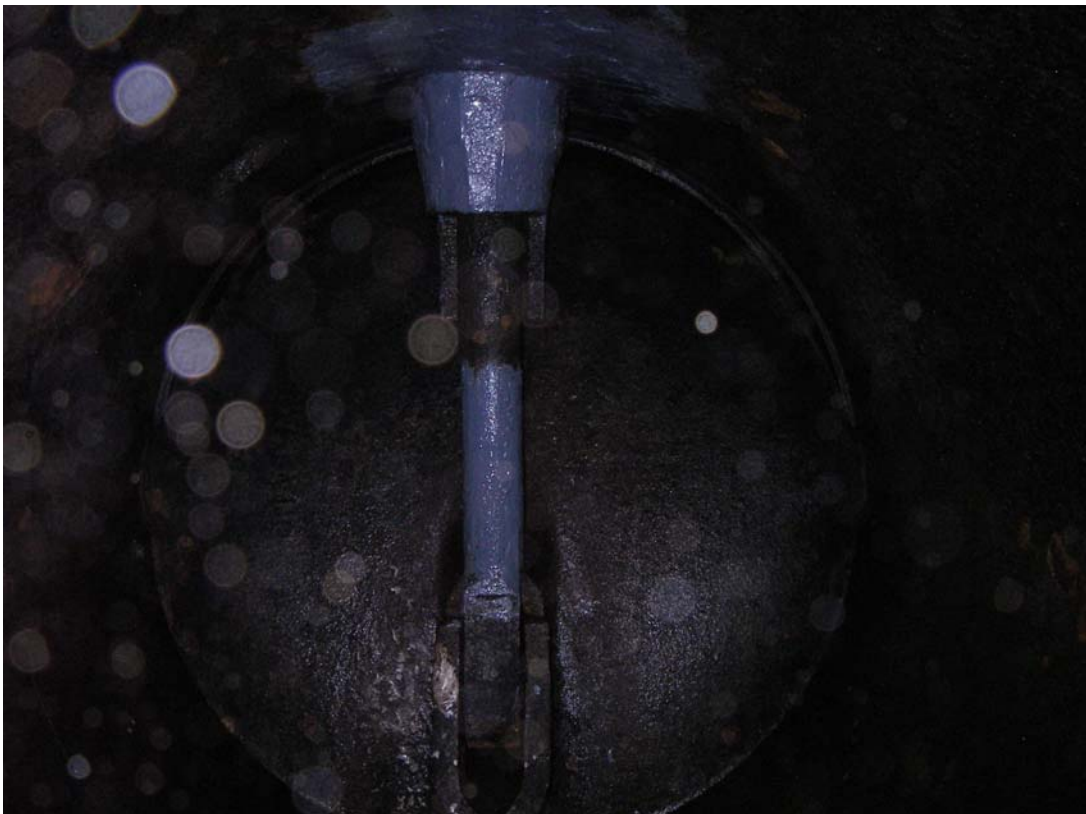
**Section 3.C.(7).** There is cavitation damage on both sides of the operating gate stem deflector, around the jet pump outlet, and on the crown of the conduit. Previous reports indicate that the damaged areas are typically repaired on an annual basis (from 2007 inspection).

Cavitation repairs were performed in July 2008 by SWPB personnel. During the 2008 inspection the conduit was in good condition. Cavitation repairs were in good shape (Photos 6, 7, and 8). There were several minor chips areas on front of the gate stem deflector where excess material had been smeared out.

Photo 6 – Cavitation repairs.

Photo 7 – Cavitation repairs.

Photo 8 – Cavitation repairs.

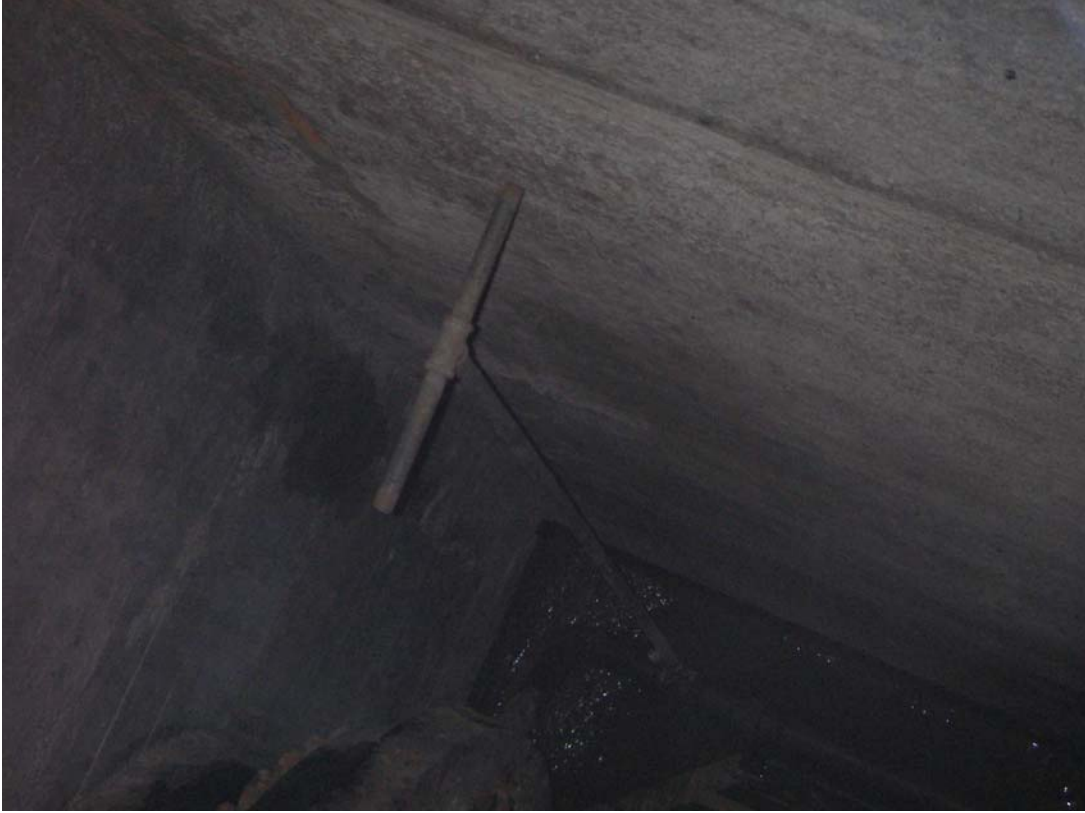
**Section 3.C.17** An attachment from the gatehouse wall to the ball valve handle for the downstream valve that prevents backflow into the tower needs to be made. The attachment should be able to hold the ball valve handle approximately 9 inches away from the wall and stabilize the handle (Photo 9). The threaded stem connection also needs to be locked so that it does not unscrew when attempting to open the valve.

Photo 9 – Handle that needs stabilizing attachment to wall.

1. Cover the concrete wet well located on the left side of the old measuring weir. (July 2009).
2. Make an attachment from the ball valve handle in the gatehouse to the wall to stabilized the handle during operation.

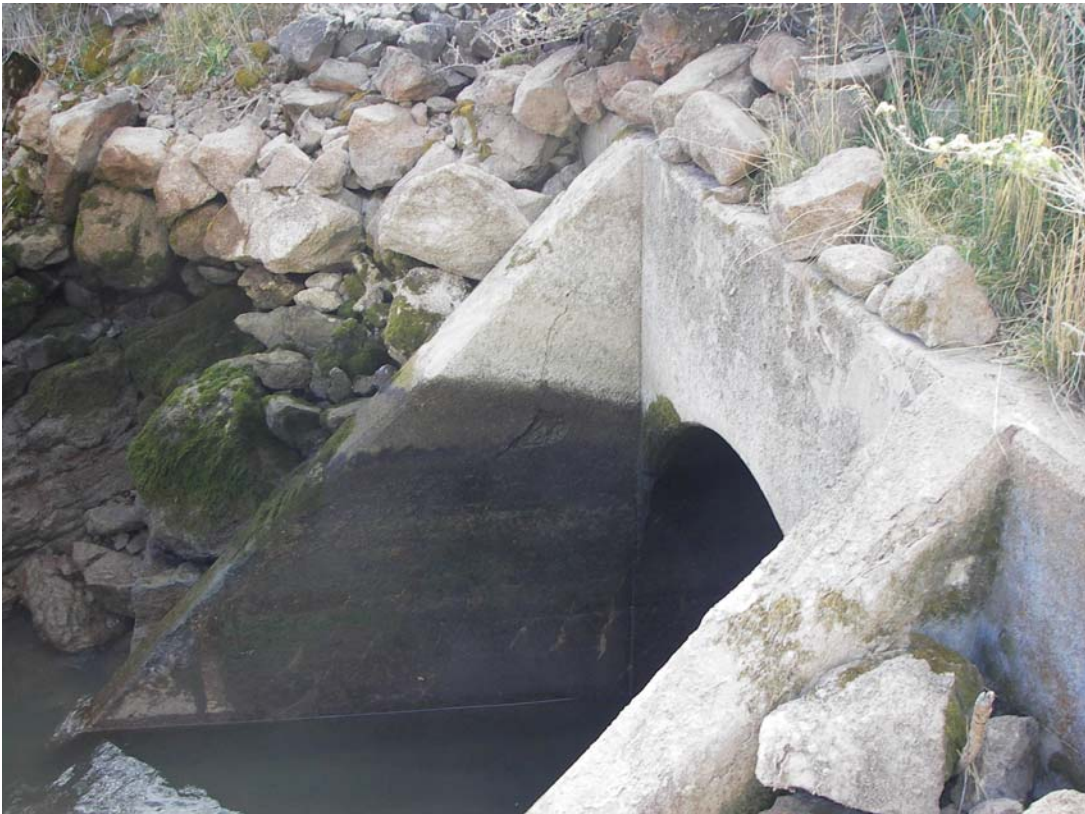
**Section 3.D.(1).b.** The concrete outlet structure is severely cracked and severely spalled in several places (Photo 10). The damage does not appear to be fresh or rapidly worsening (comment from 2007 report).

Photo 10 – Outlet works with cracks and chips.

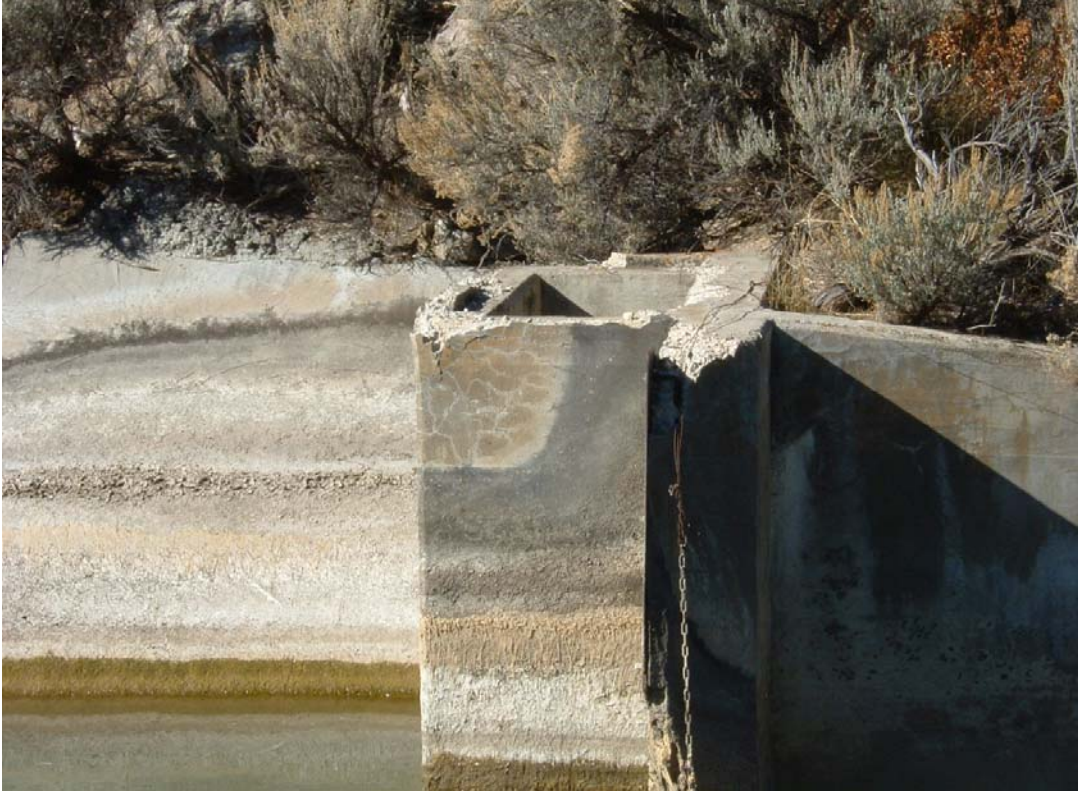
**Section 3.E.(3).** There is a measuring weir across the outlet channel that includes a square concrete wet well (Photo 11). The wet well has a square (approximately 2' x 2') opening at the top and is very deep. The opening is not marked and is potentially very dangerous. The wet well should be covered and secured. (2007 Report).

Photo 11 – Wet well that needs to be covered.

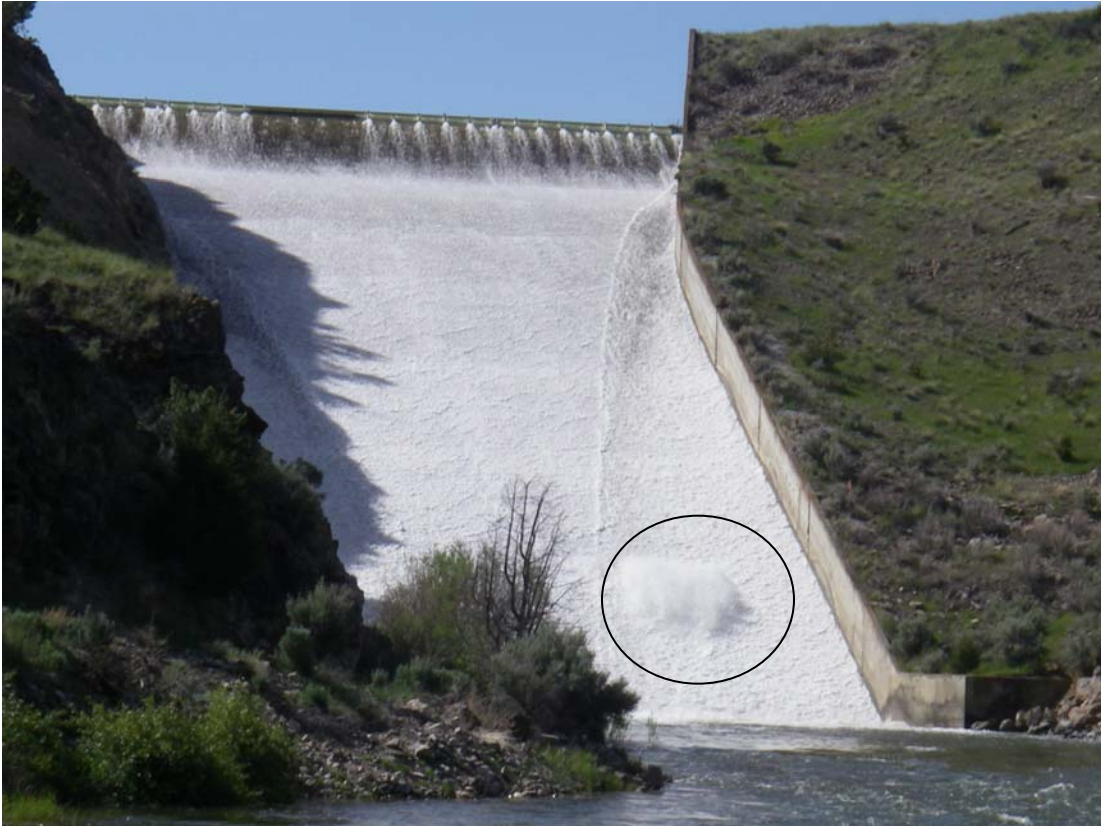
**Section 4.A.(6).** The spillway is in very poor condition. The spillway floor was repaired in 1965, 1994, 1998, 2007, and again in 2008. When the reservoir started spilling in 2008, spalling occurred on the lower left hand floor of the spillway creating a large wave of water (Photo 12). After spilling stopped, the spillway showed extensive damage along one of the joints (Photo 13). Numerous areas on the spillway floor were repaired with concrete (deep repairs) and SIKATOP 123 PLUS (shallow repairs) during September 2008 (Photos 14, 15, 16 and 17).

Photo 12 – Spillway with wave (rooster tail) from damaged area.

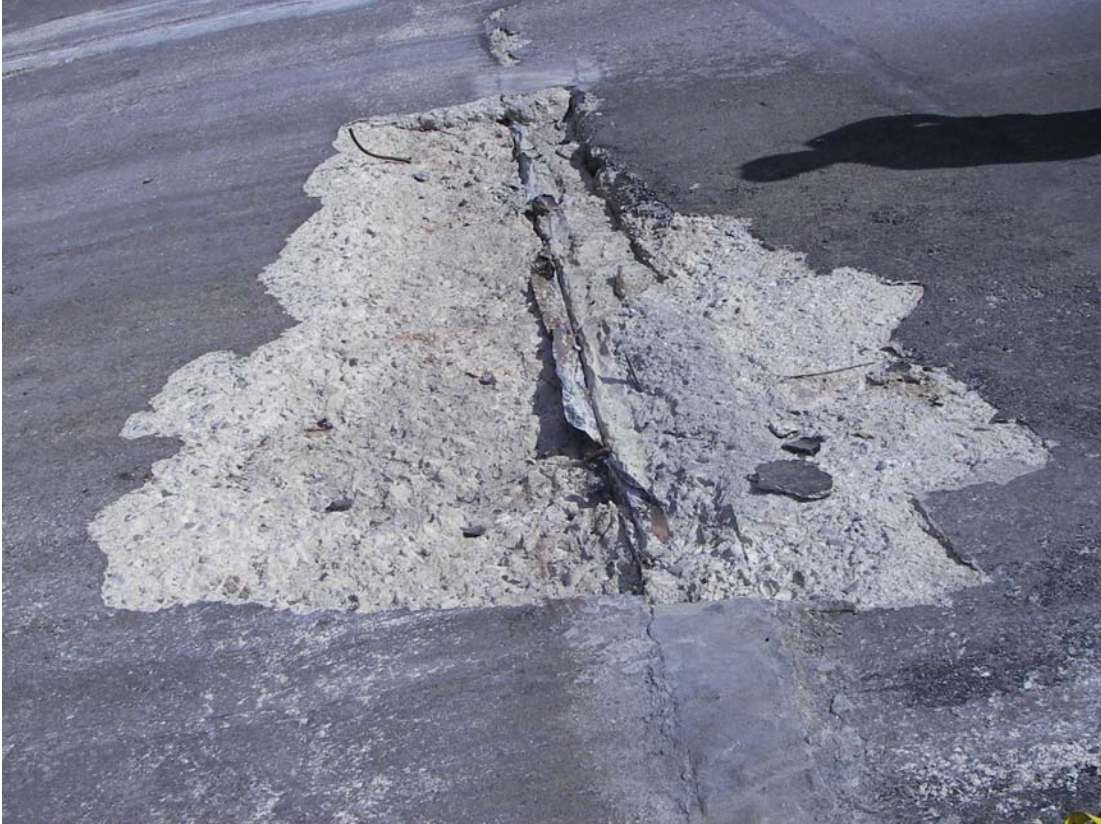
Photo 13 – Spillway damage after 2008 spilling.

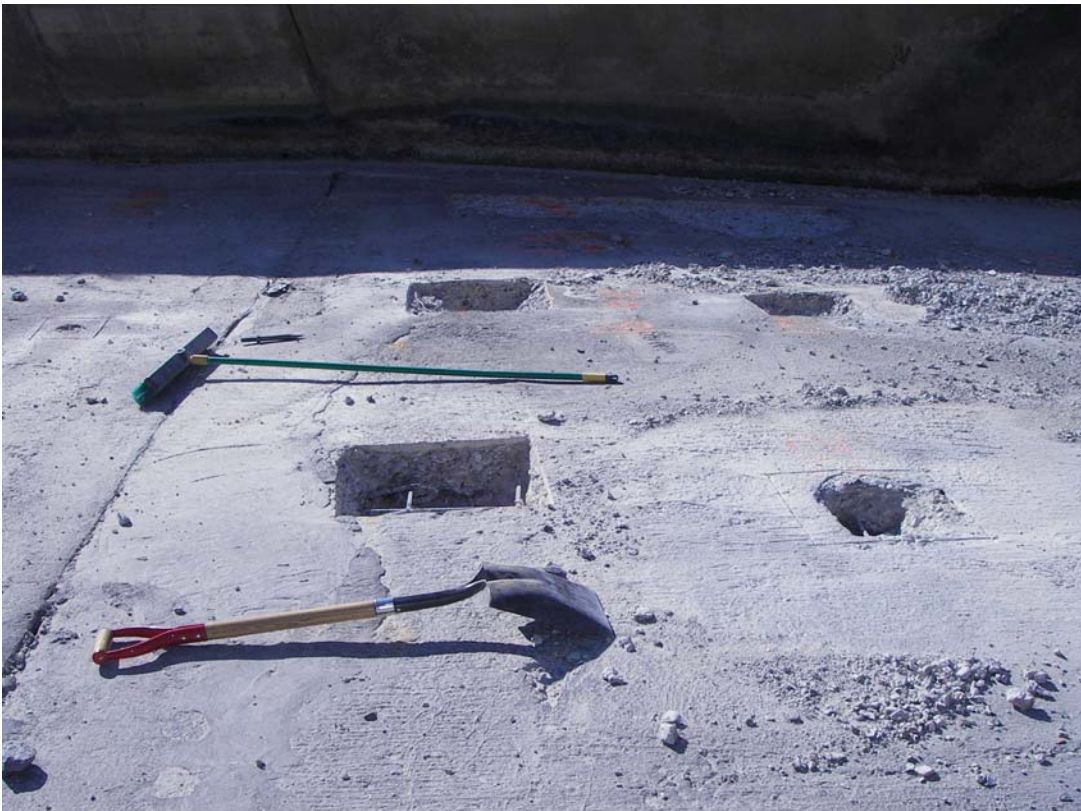
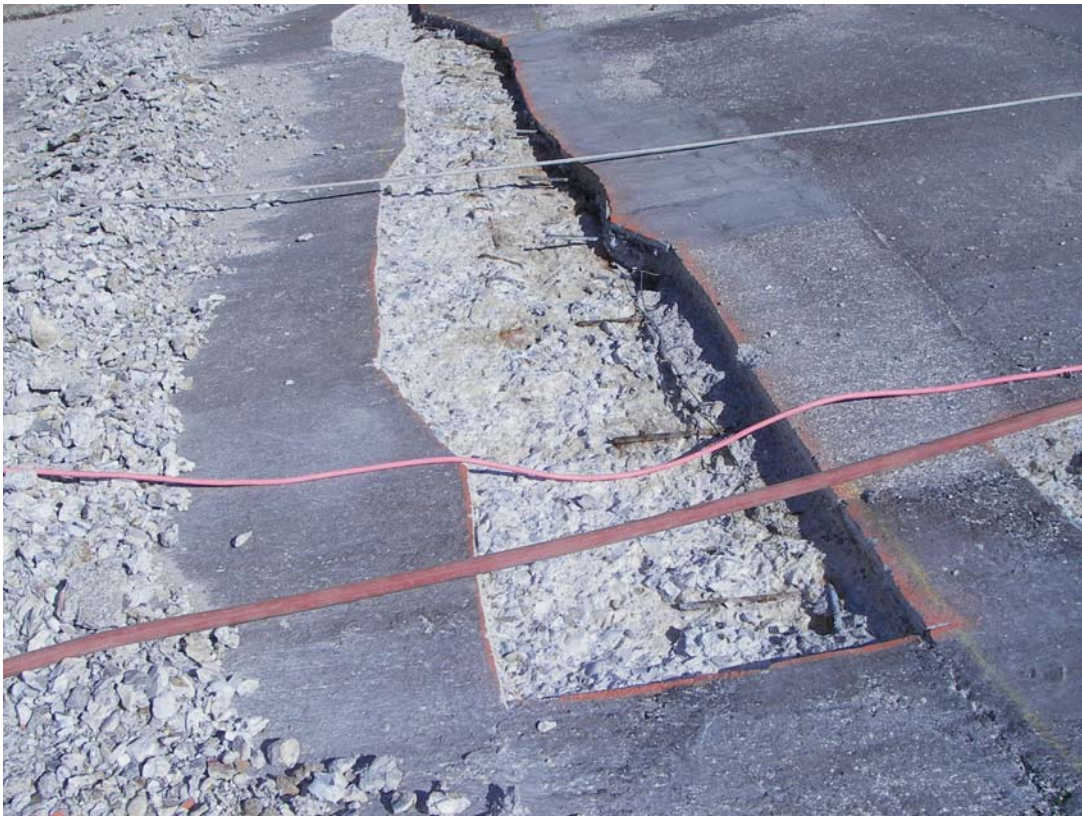
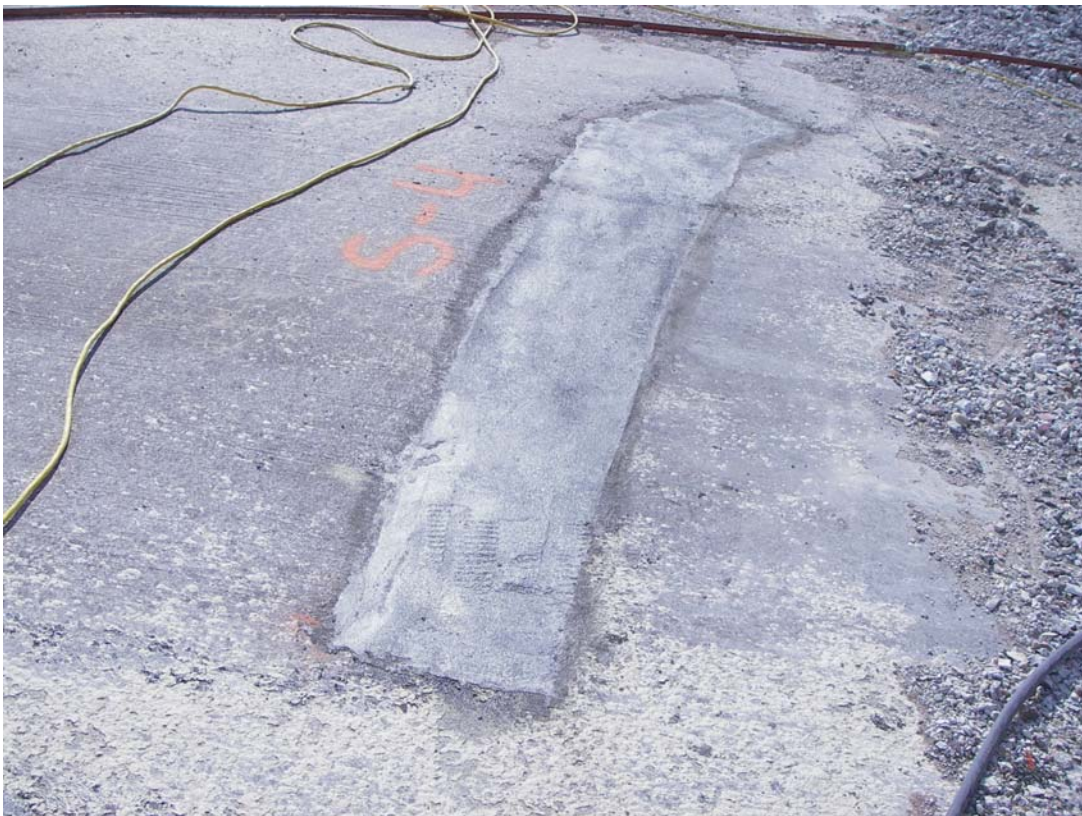
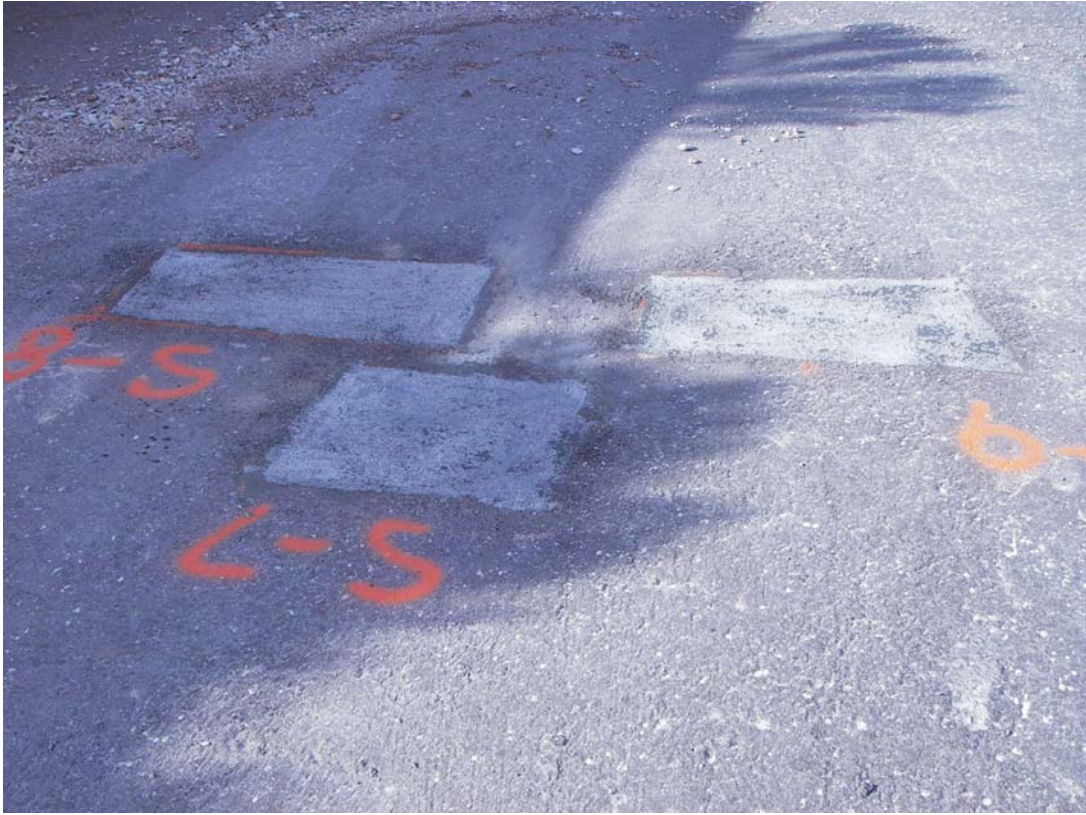
Photo 14 – Breaking out damaged concrete in spillway.

Photo 15 – Breaking out damaged concrete in spillway.

Photo 16 – Spillway repair.

Photo 17 – Spillway repairs.

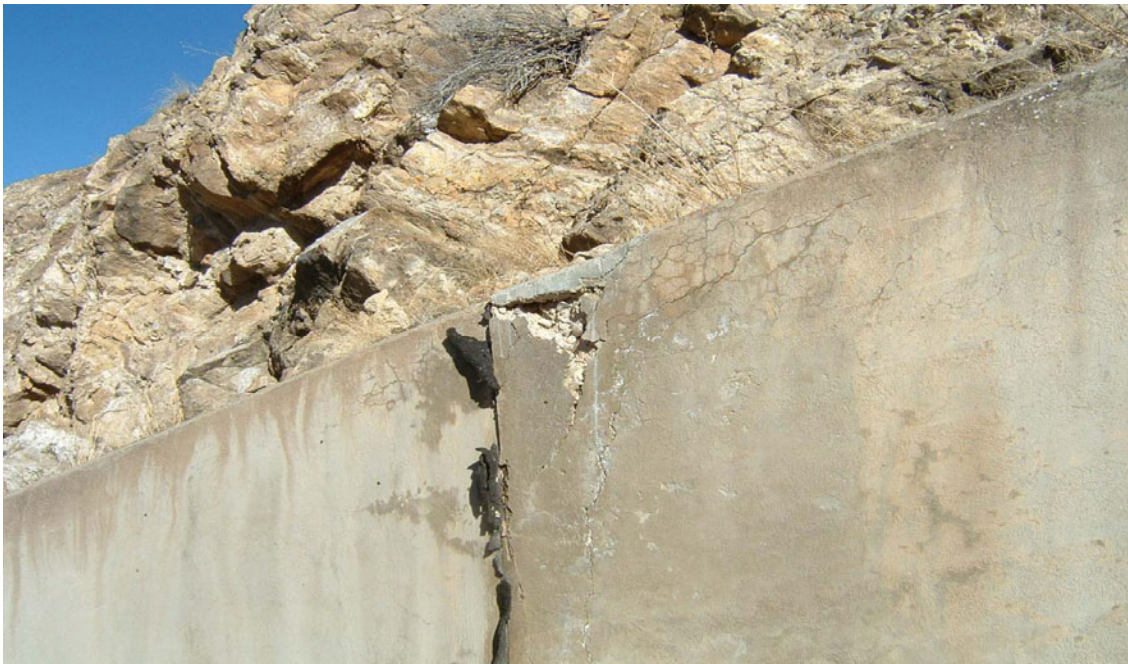
Both spillway walls are also in very poor condition. Pattern cracking (D-cracks) and significant spalling (Photo 18) are typical along the tops of both walls.

Photo 18 – Damaged spillway wall.

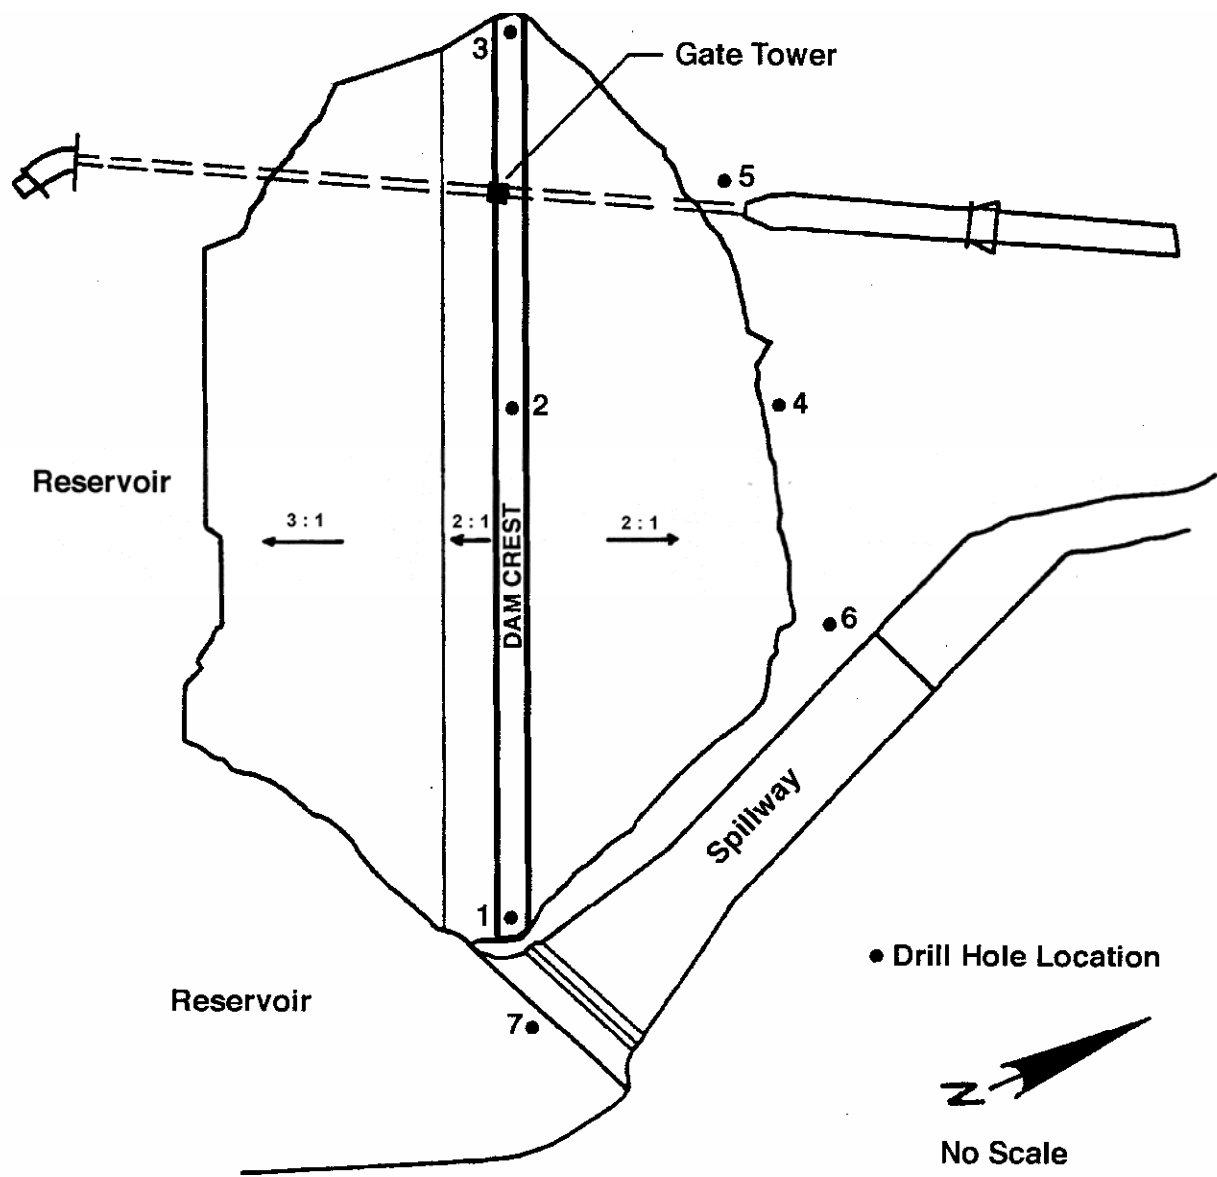
Figure 1 – General Site Layout, Ruby River Dam

**Section 6.(A).** In the fall of 1999, 13 piezometers were installed in 7 drill holes. They are located in the spillway approach channel, through the dam crest, and at the toe of the dam (see Figure 1.) The most recent piezometers and reservoir elevation data is shown in Figure 2, 3 and 4.
